**TOWN OF BAY HARBOR ISLANDS  
9665 BAY HARBOR TERRACE  
BAY HARBOR ISLANDS, FL 33154**

**SPECIAL COUNCIL  
MEETING  
AGENDA**

## **AGENDA ITEM REPORT**

**ITEM: Discussion** and **Possible** Action related to Town Hall Facilities.

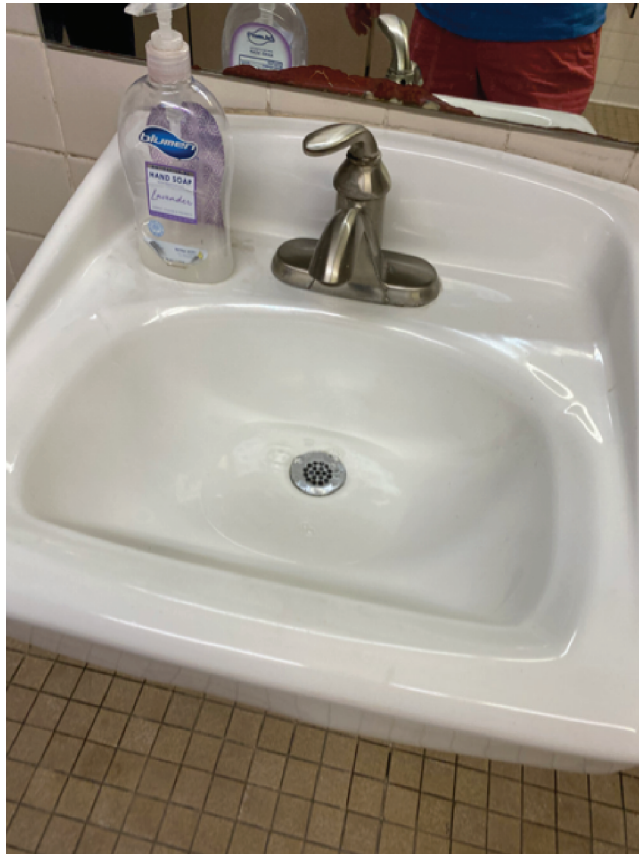
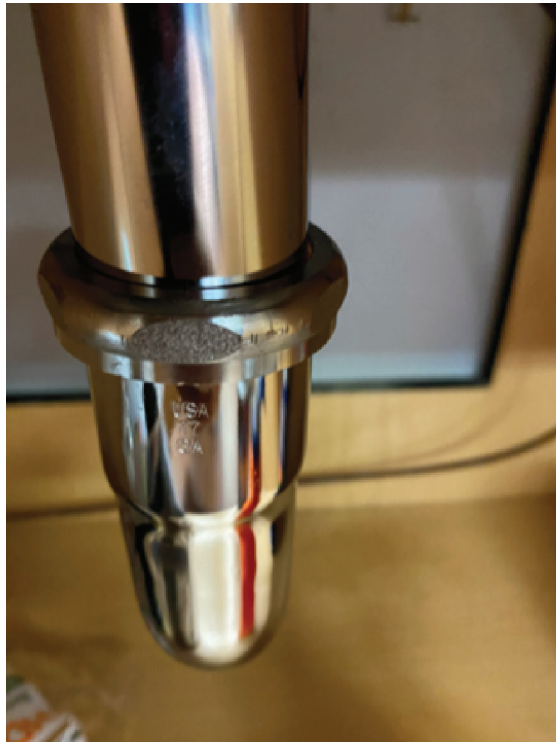
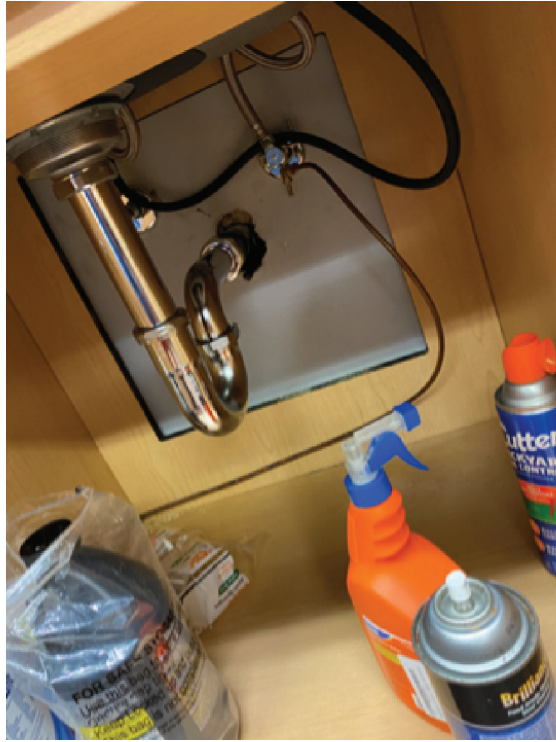
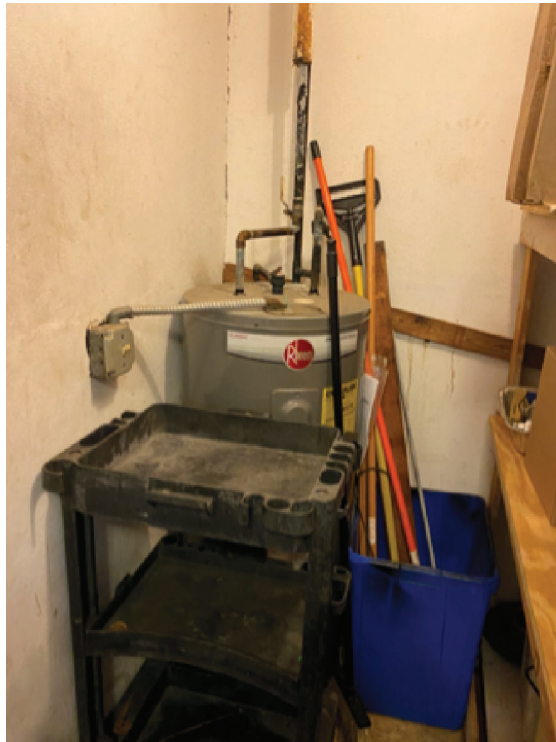
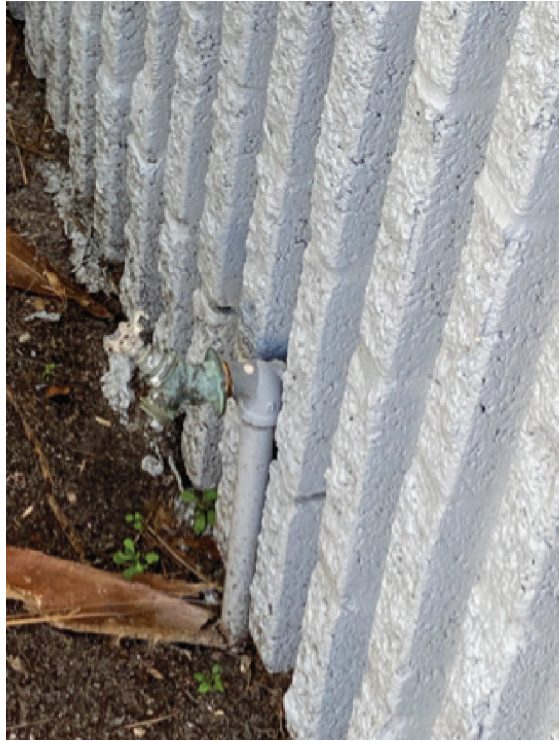
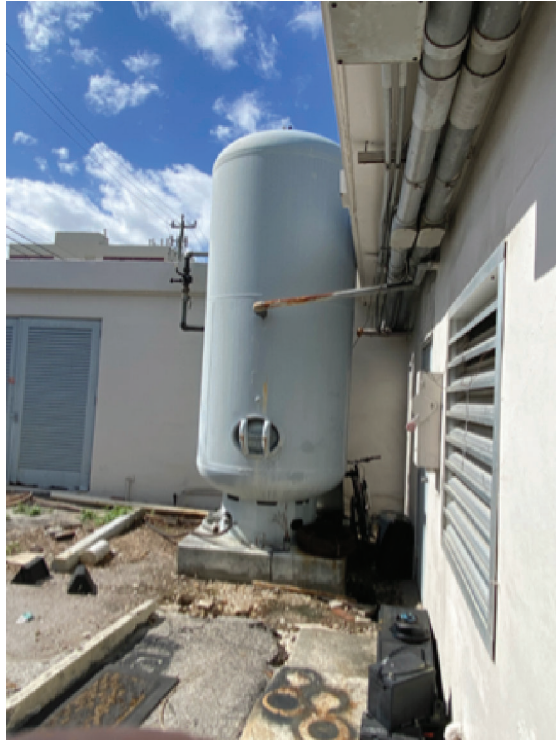
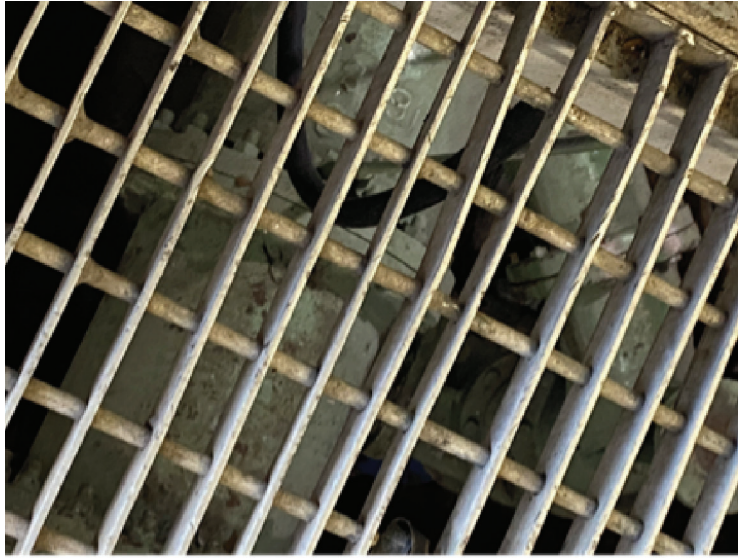
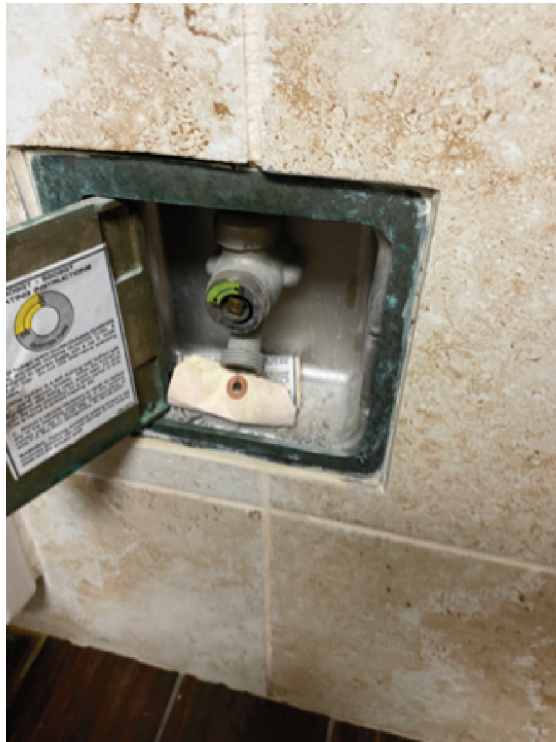
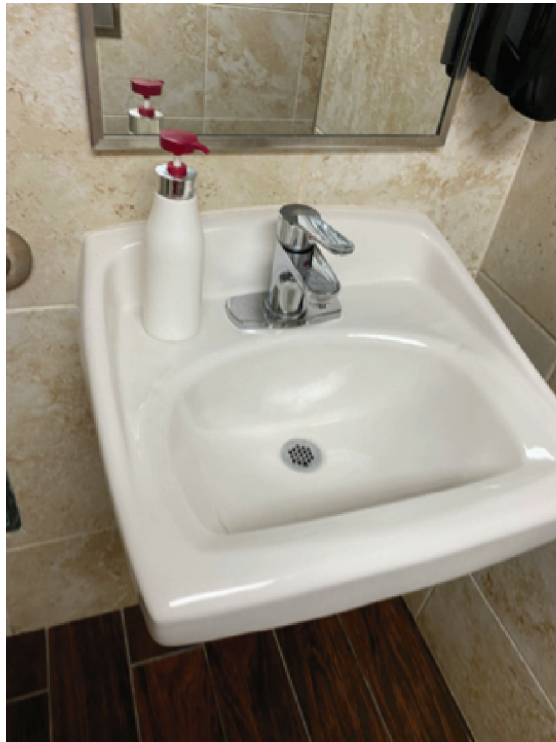
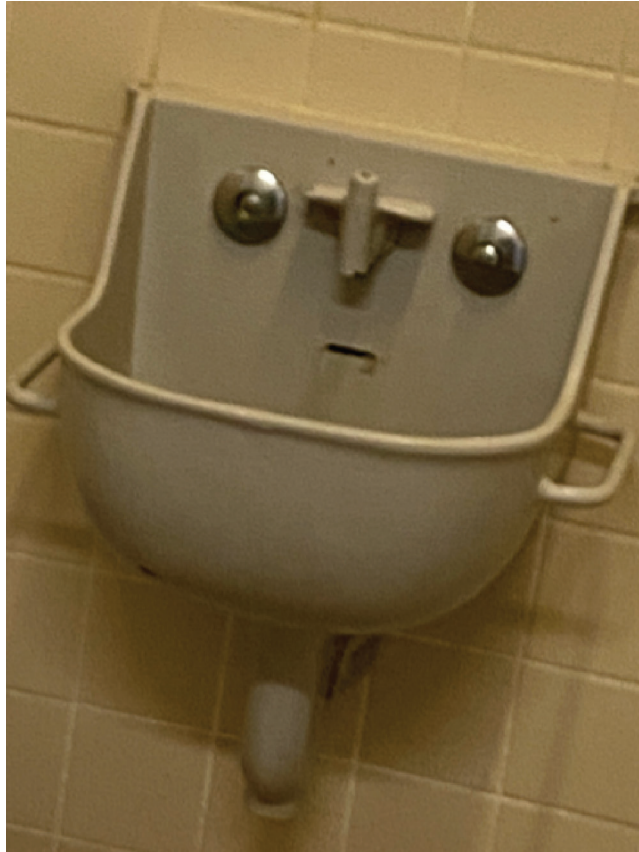
After inspections of all bathrooms water heater and drain lines .. at this time we see no issues, the building is piped in type ( L ) or better copper water lines , and 2nd floor has been up dated to schedule 40 PVC drains and type L copper water lines .. all seems to be in good operational condition at this time , there has been no history of plumbing issues, besides a lav stoppage In any recent history according , To maintenance , all fixtures seem to be in good working condition, the building still has solid commercial grade cast iron sanitary lines
